Manhole Inspection Summary

Manhole # S17Y__003MH

Insp Date: **6/24/08 8:27 AM**

Location Address: **1713 wilmington av**

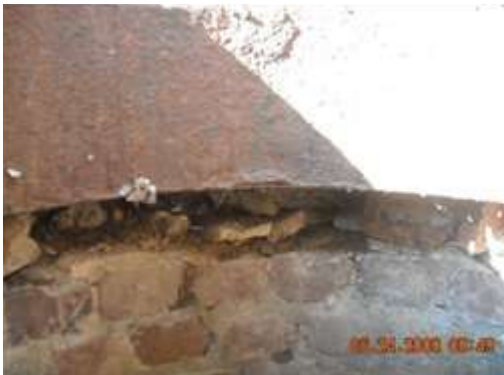
Defect 3

Condition: ☐ Sound ☐ Cracked ☐ Root Intrusion ☒ **Loose Brick** ☒ **Deteriorated**

deteriorated chimney bricks

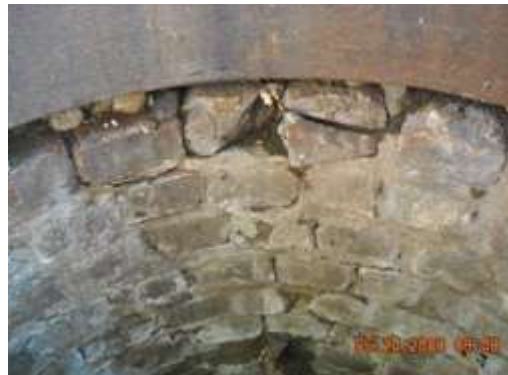
Defect 2

cracked chimney bricks

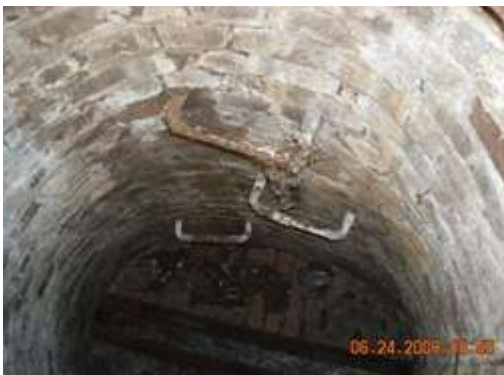
Defect 1

Infiltration: ☐ None ☐ Joint ☐ Cracks ☐ Mortar ☐ Roots ☒ **Wall**

Steps Count: **3** Missing: **0** ☒ **Corroded**

corbel flow wall, barrel flow wall, corroded steps

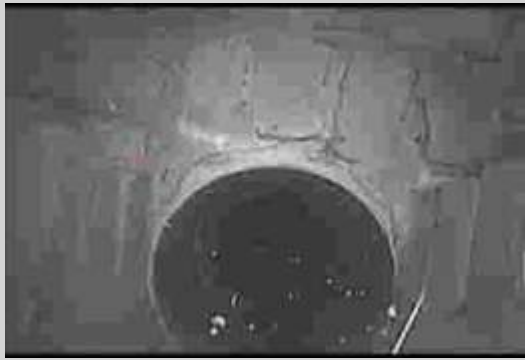
12 O'Clock Outflow

8 in. Circular Gravity Sewer
Pipe Out @ 12 O'Clock

Pipe Height: **8.4** (in.) Rod and Bar (Angled)
Pipe Material: **Clay** ☐ Pipe Lined
Invert Depth: **7.75** (ft.) Flow Characteristics: **Slow**
Deposits: ☒ None ☐ Mud ☐ Sludge ☐ Debris ☐ Grease
Silt Depth: **0** (in.) Deposits Extent:
Infiltration: **None** Pipe Seal Cond: **Sound**

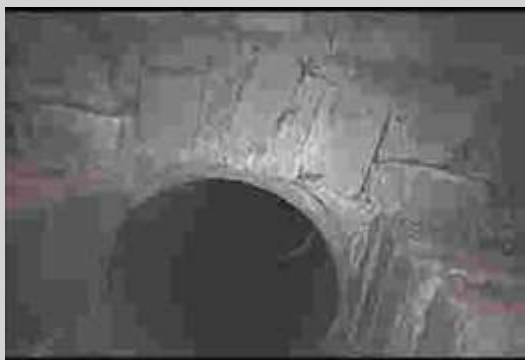
6 O'Clock Inflow

8 in. Circular Gravity Sewer
Pipe In @ 6 O'Clock

Pipe Height: **8.4** (in.) Rod and Bar (Angled)
Pipe Material: **Clay** ☐ Pipe Lined
Invert Depth: **7.30** (ft.) Flow Characteristics: **Slow**
Deposits: ☒ None ☐ Mud ☐ Sludge ☐ Debris ☐ Grease
Silt Depth: **0** (in.) Deposits Extent:
Infiltration: **None** Pipe Seal Cond: **Sound**
